Life-Threatening Effect of Twiddler's Syndrome with a Subpectorally Implanted Cardioverter Defibrillator

M. ZACHER, D. MARTINOVIC, A. DIEGELER
Kardiologie, Herz- und Gefäß-Klinik GmbH, Bad Neustadt/Saale, Germany

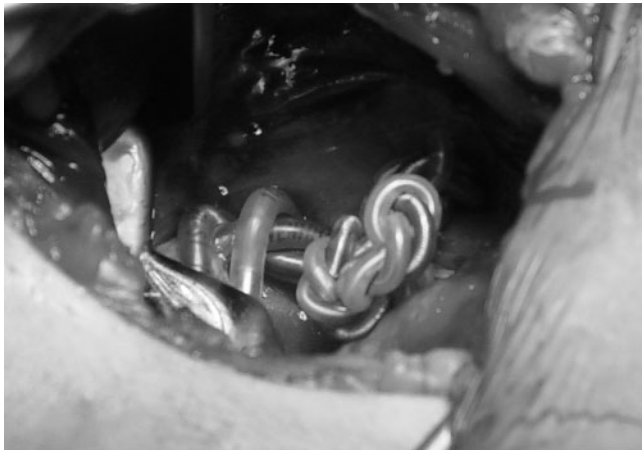
Figure 1. Device "in situ."

In March 2001, the patient received a Microphylax Plus ICD (Biotronik, Germany) in a subpectoral position. An incision was made over the sulcus deltopectoideus, and the intermediate cephalic vein was actively dissected. A quadripolar Kainox 75/16 lead (Biotronik, Germany) was then advanced through the intermediate cephalic vein and placed in the right ventricular apex. In order to prevent lead dislocation, the lead was fixated in the fascia of the deltoid muscle. Within anatomic structures, a pocket was created between the major and minor pectoral muscle using blunt dissection. After the lead was connected to the pulse generator, the latter was inserted in the pocket using

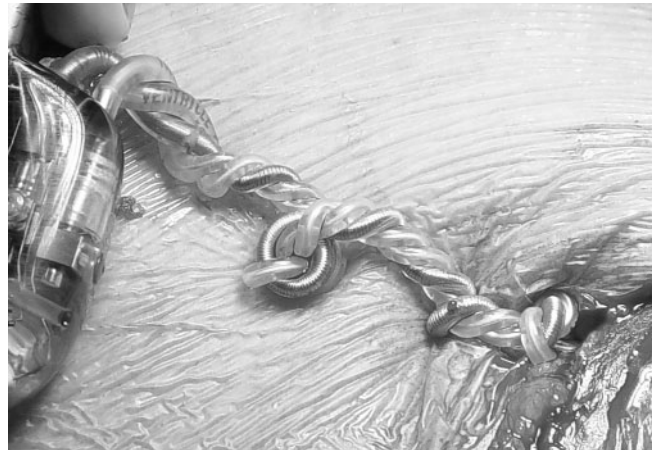
Figure 2. Device after explantation: 11.5-fold clockwise rotation.

slight pressure. The device had a tight fit in the pocket of the muscular and slightly adipose patient. An additional fixation suture was not performed. All measured values and the defibrillation threshold were normal. A 3-hour postoperative bed rest was imposed on the patient, during which a sandbag was placed on the wound. The subsequent out-patient ICD follow-up results were normal. No adverse reactions were noted. In July 2002, the patient again experienced symptoms of angina pectoris. Coronary angiogram showed a progression of the coronary heart disease with an occlusion of the right posterolateral branch and high-grade stenosis of the diagonal branch of the right coronary artery. During angiography of the right coronary artery, ventricular fibrillation was triggered. This was detected by the ICD, but the automatic defibrillation shocks failed to terminate the arrhythmia. The patient was resuscitated and externally defibrillated three times. Subsequently, the implanted device paced appropriately in VVI mode. Based on ICD interrogation, a lead defect was suspected in the high-energy circuit. Exploratory surgery conducted in July 2003 indicated that the cause of the lead break was a 11.5-fold rotation of the device around the longitudinal axis. The lead was removed and replaced by a new lead of the same type. The device was reimplanted in the same pocket. The position of the pulse generator was fixated by the suture to the fascia of the minor pectoral muscle. The subsequent 14-month observational period (to date) showed no further adverse events and normal ICD parameters.

and has not lost any weight in the meantime. The device was implanted submuscularly, and the pocket was not significantly larger than the pulse generator even after the revision. The patient denied that he had manipulated the ICD, there were no complaints, and the wound looked outwardly normal. It can thus be maintained that Twiddler's syndrome can occur even when none of the accepted risk factors are present. The implanted pulse generator was hardly palpable, and a habitual manipulation of the device by the patient seems improbable. The patient is a mason by trade and at least sporadically resumed his professional duties after the implantation. The question is whether – for people who are physically active and are also engaged in manual work that is above head level – it is possible to rotate the device by simply engaging in muscle-intensive work. For these patients at least, the exact pathologic mechanism of Twiddler's syndrome remains to be clarified.
